## The Department of Communications, Energy and Natural Resources

### Feasibility Study for Management and Remediation of the Avoca Mining Site

#### Executive Summary

December 2008

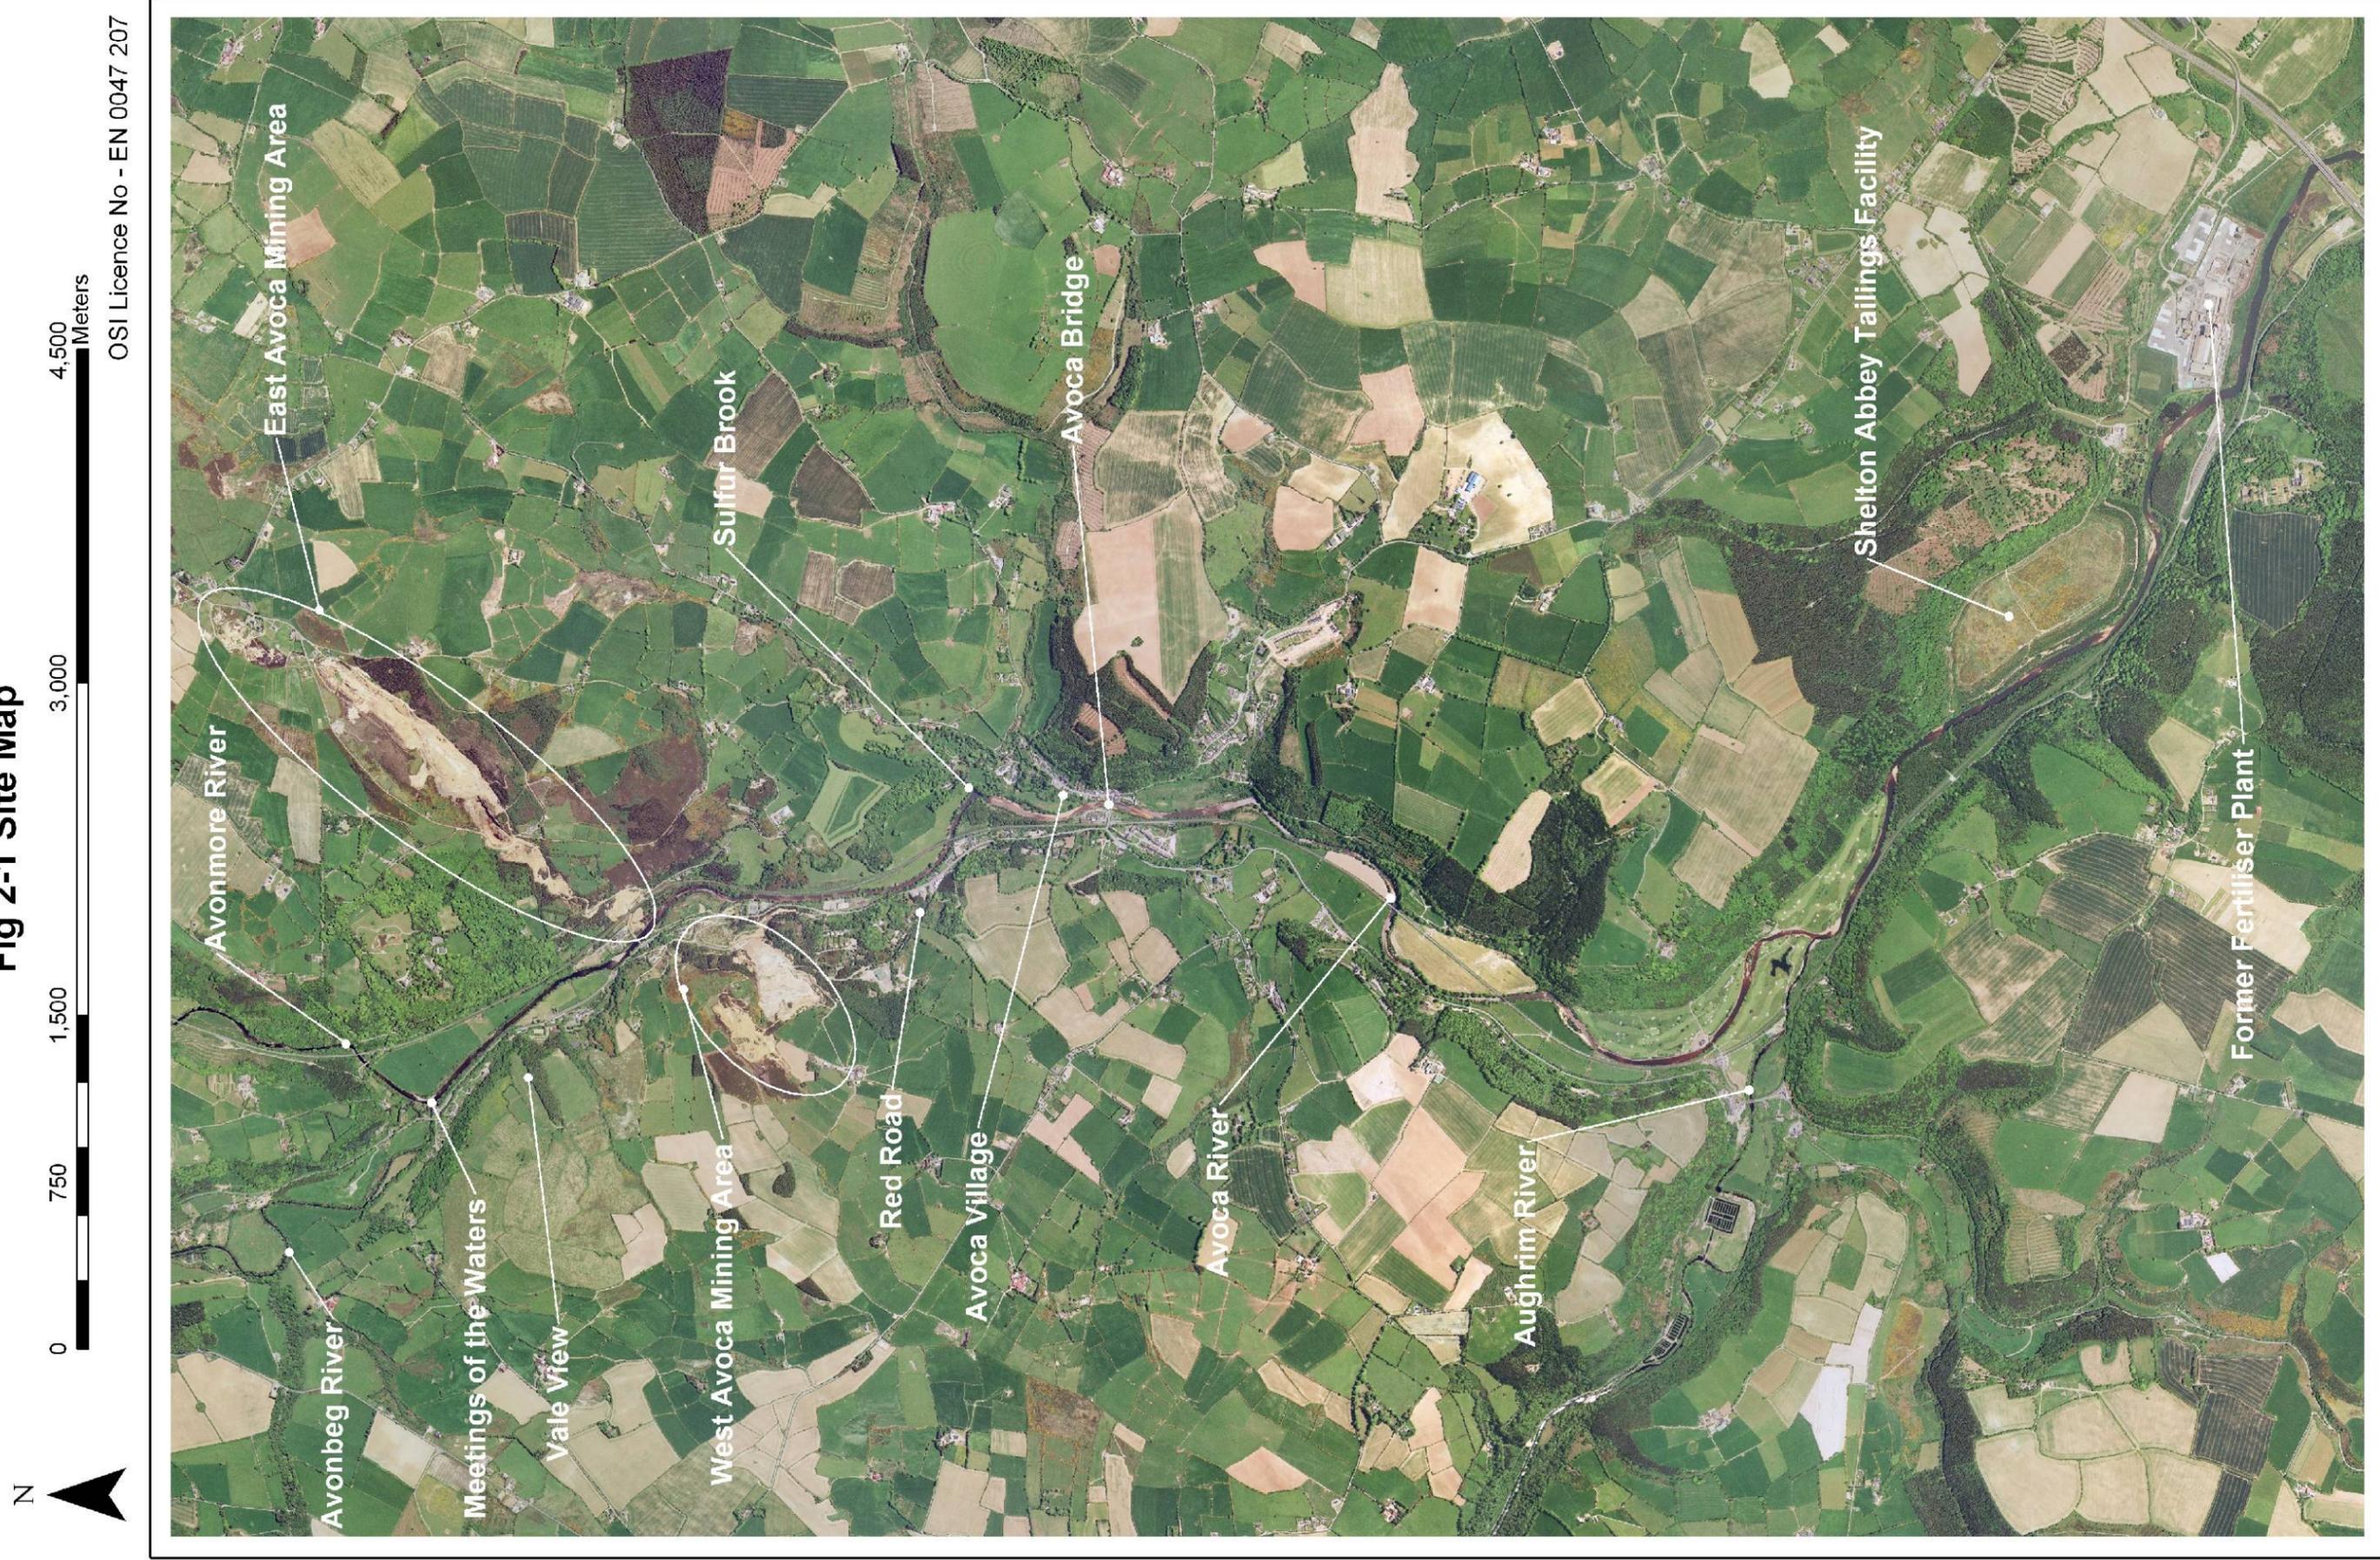
**Fig 2-1 Site Map**

The East and West Avoca mine sites cover 0.34 square kilometres (km<sup>2</sup>) and 0.29 km<sup>2</sup>, respectively, extending from the Avoca River onto the higher ground on either side of the valley to the northeast and southwest. The surface water and groundwater drainage from the Site has been heavily modified and groundwater levels are lower as a result of mining. The East Avoca area mainly drains through the 19th Century Deep Adit and flows into the Avoca River through a short surface channel. There are also a few smaller higher-level discharges that either return underground or flow into small streams. West Avoca is drained by the 19th Century Road Adit beside the main Avoca/Rathdrum Road and flows through a ditch and pipe into the Avoca River.

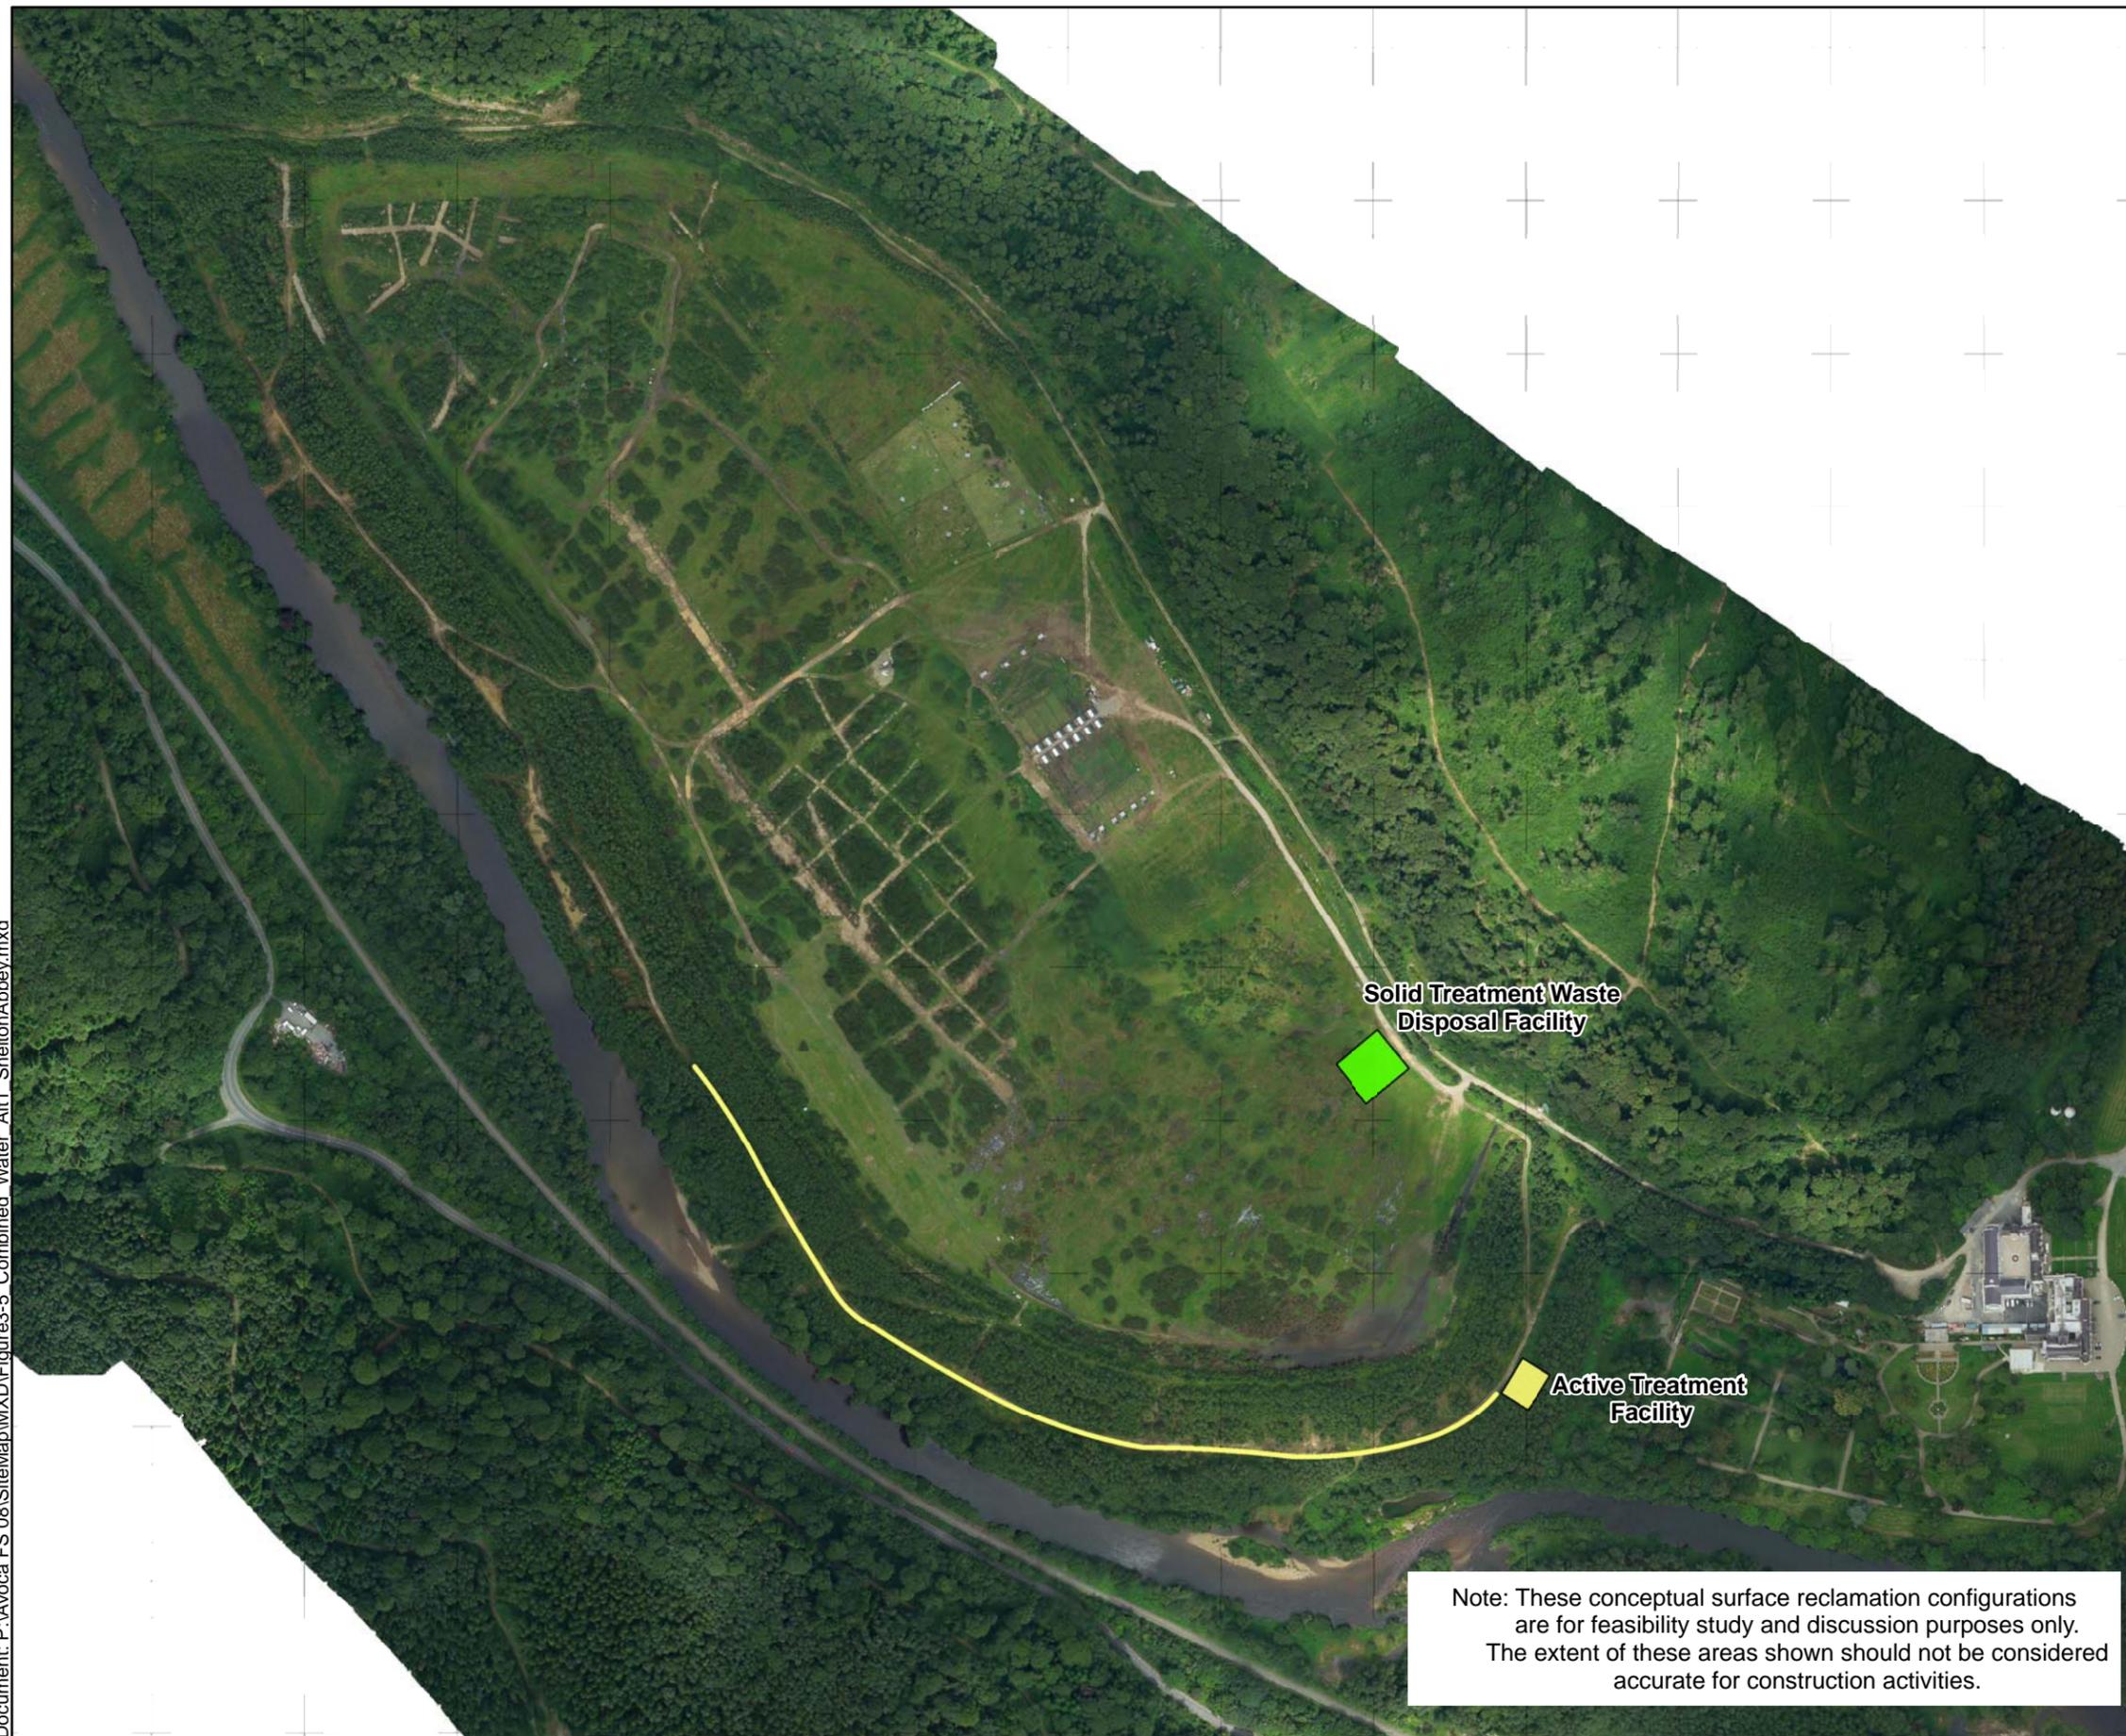
Combined Alternative 1 - Water  
East/West Avoca

Note: These conceptual surface reclamation configurations are for feasibility study and discussion purposes only. The extent of these areas shown should not be considered accurate for construction activities.

- Soil-Bentonite Barrier and Pump-Back System
- \* - Implement appropriate institutional controls, such as access control (fencing, gates) and legal restrictions.

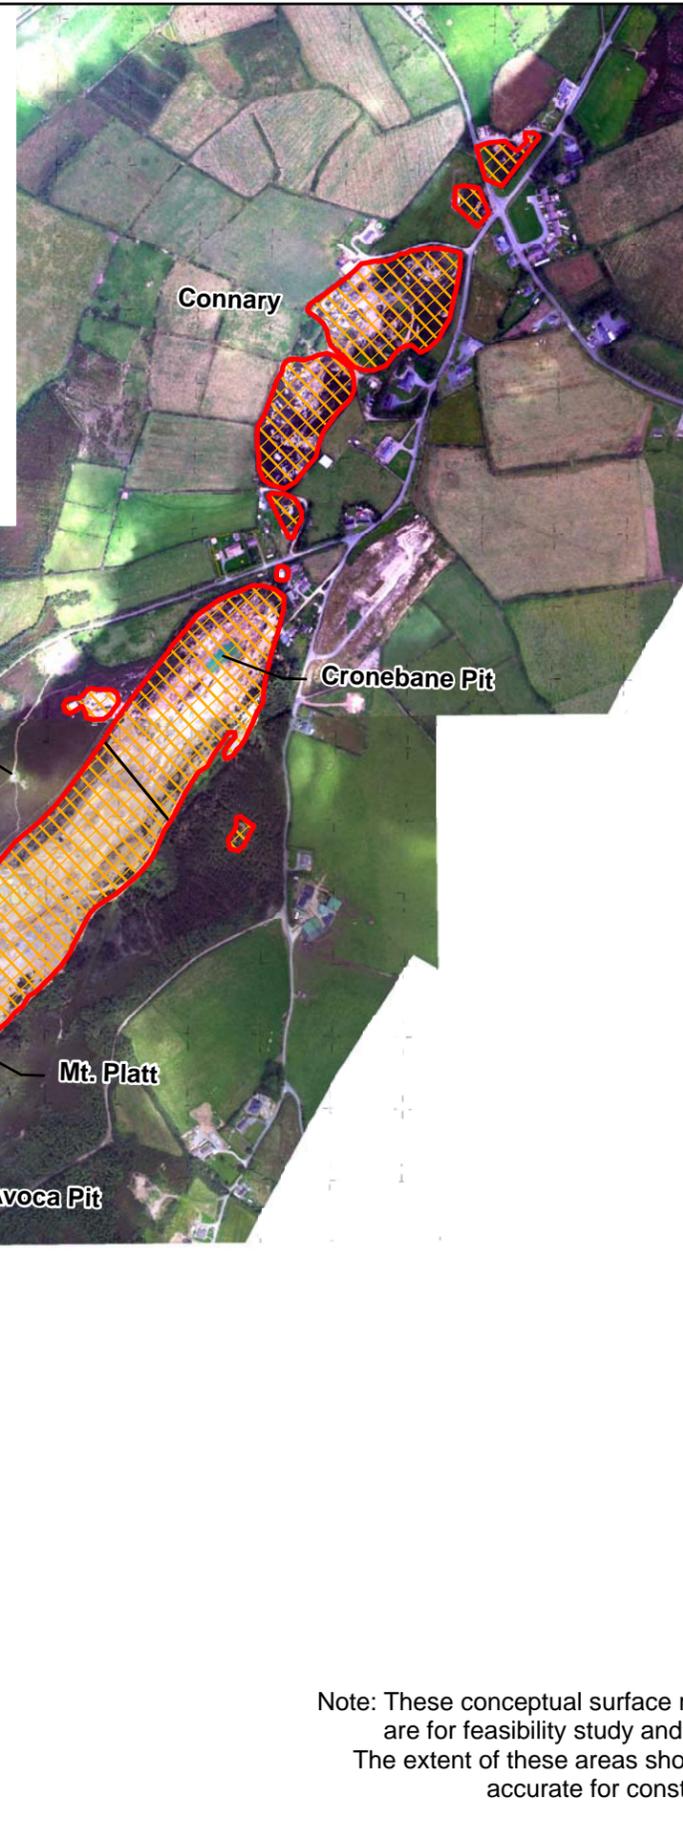
Location	Cap/Cover Type			Backfill	Remove/ Relocate Spoils	Regrade
	Imported Soil	HDPE	Lime Amendment			
Connary	•					•
Mt. Platt	•				•*	•
Cronebane Pit	•			•		•
East Avoca Pit	•			•		•
East Avoca (Unstable Area)	•				•	•
Tigroney West/Ore Bin Spoils Area	•					•
Deep Adit Spoils Area	•			•	•	•

\* - Approximately 80 percent of Mt. Platt would be removed to obtain stable slopes
